LIFE-SIP AdaptEst. Ensuring the sustainability of fish stocks in changing climate.

RECONNECTING RIVERS: RESTORING MIGRATORY FISH HABITATS IN ESTONIA

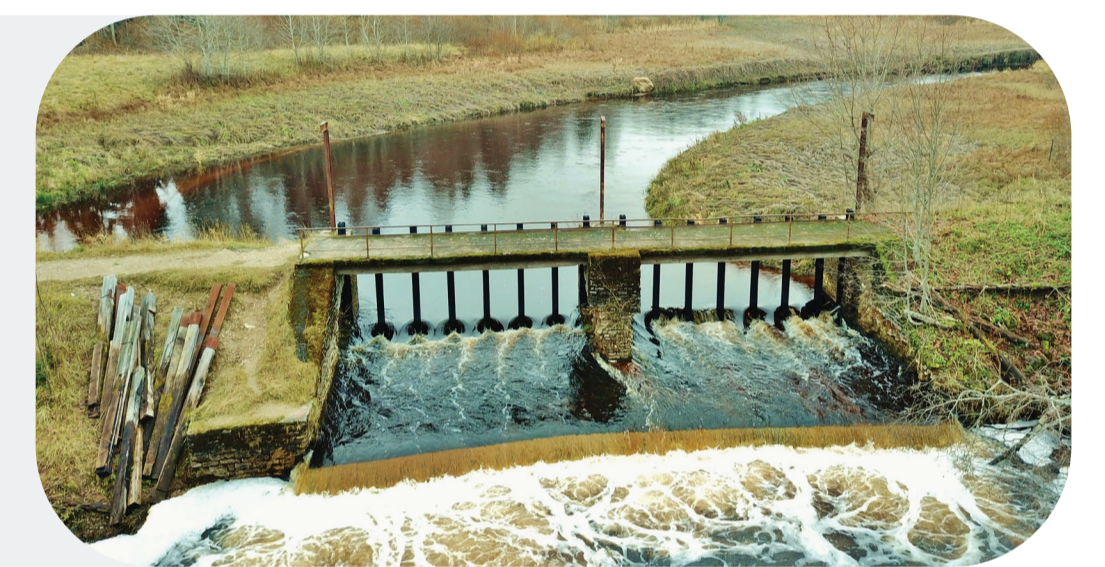
Kotka Dam [0,8 m ↑] - Valgejõgi

Valgejõgi is about 90 km long and is one of Estonia's most important salmonid rivers. Located about 8 km from the river mouth, Kotka dam historically blocked around 80% of suitable spawning habitat.

Although the dam broke in 2016, the remaining 0,8 m concrete threshold still restricts fish migration, especially during low flows.

The goal is the full removal of the remaining structure and the restoration of the natural riverbed.

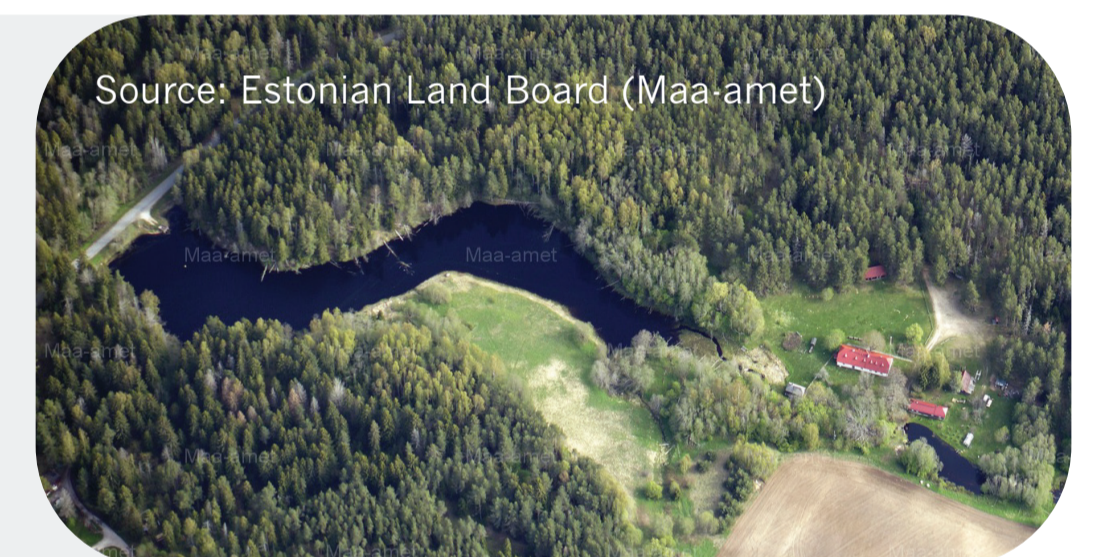
Ojaäärse I Dam [3,5 m ↑] - Võsu River

Ojaäärse I dam has an impoundment height of 3,5 m, and the goal was to restore the natural riverbed.

Although on state land, the project required negotiations. The structure lies beneath a paved road, borders Palmse Manor park on one side and Natura 2000 habitats on the other, and raised concerns among the local municipality and residents.

The plan is to remove the dam and restore the natural riverbed. The technical project was adjusted through negotiations with the relevant authorities and concerned parties, including slight modification of the habitat boundary to enable the works.

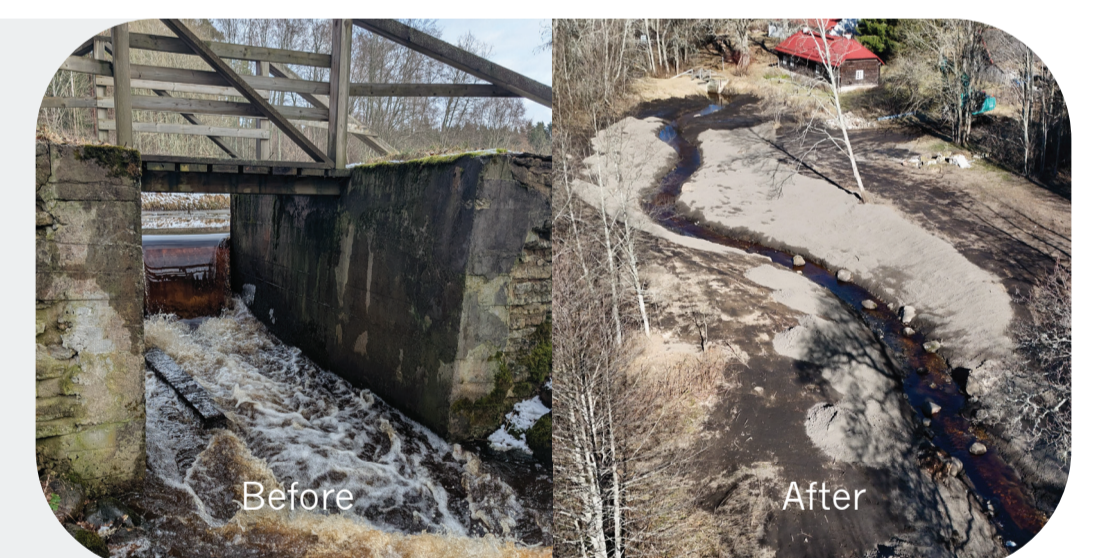
Ojaäärse II Dam [1,6 m ↑] - Võsu River

Ojaäärse II is located about 400 m upstream of Ojaäärse I on the Võsu River. The dam is located entirely on state-owned land, with only a few private owners nearby.

In 2025 the water level was lowered, and within months the reservoir became a green area. As recovery was faster than expected, the plan was reduced. The new plan is to regrade the banks and remove an old inflow regulator upstream.

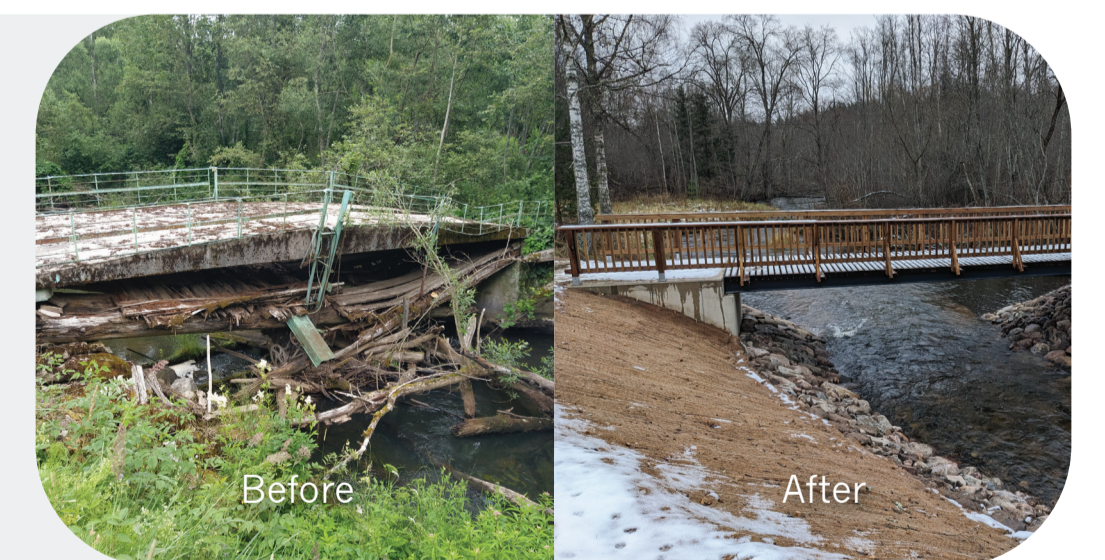
Rundsoveski Dam [0,6 m ↑] - Elva River

Although the Rundsoveski dam was only 0,45m high, it was still considered difficult to pass for some species.

This project required compromise with the landowner as the bridge had limited use but remained important. The site was in thick-shelled river mussel habitat, so all were relocated beforehand. Work was done in a temporarily diverted dry channel.

Remove the dam, replace the old bridge, relocate thick-shelled river mussels, and temporarily divert flow to allow construction in dry conditions.
